Model 2020 MkIII Brilliance Upgrade

September 1, 2004

Purpose

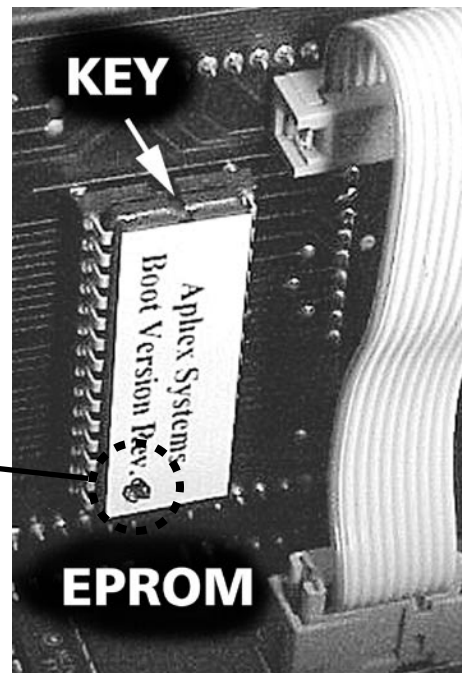
Figure 1

Locating the EPROM.
Note the orientation of the chip with the key mark at the top.

New Version 3.01!

1. Remove the Mk3 from service and place on work-bench.
2. Remove the top cover. 18 screws must be removed, including two that are located at the top of the front panel.
3. Locate the EPROM at the front of the unit as shown in figure 1. Replace it with the new version 3.01 EPROM.
4. Connect the Mk3 to a PC using a NULL MODEM cable.
5. Run the update.exe program from the V3.02 Flash Update floppy.
6. While holding down the ENTER and ESCAPE buttons on the Mk3, turn on the power switch. The Mk3 will start up and connect with the PC. The program will take over and install the new flash code. Once the code is loaded, cycle the power switch on the Mk3 and it will boot up to the menu. You can verify the running boot version is 3.01 and the flash is version 3.02.
